Lessons learned by development of UPSat Attitude Determination and Control Subsystem

Libre Space Foundation

October 15, 2019

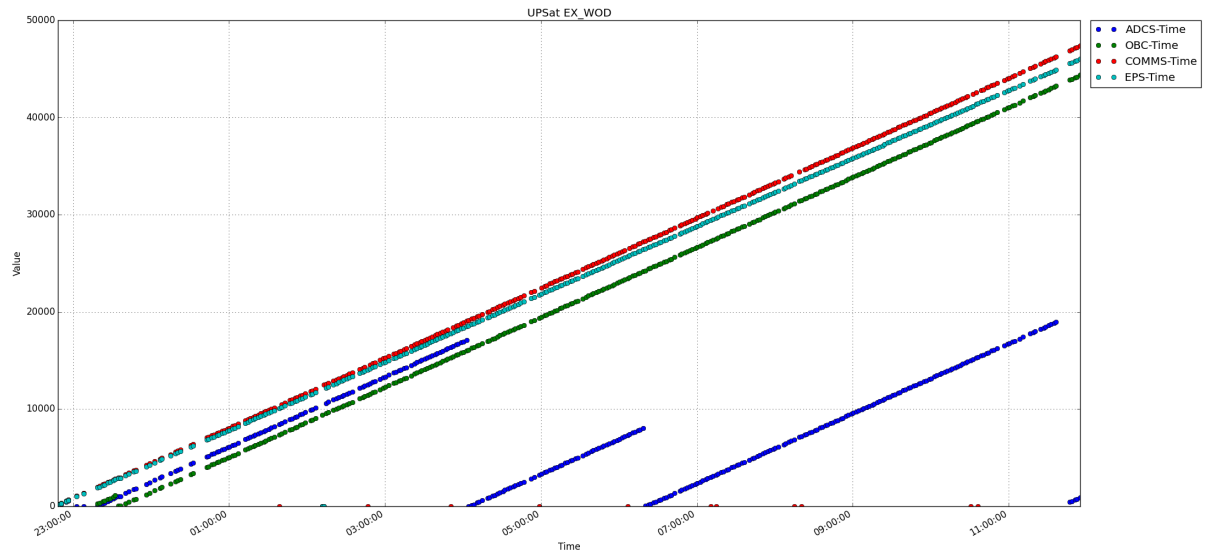
- 4 total resets in overnight test, 12 hours

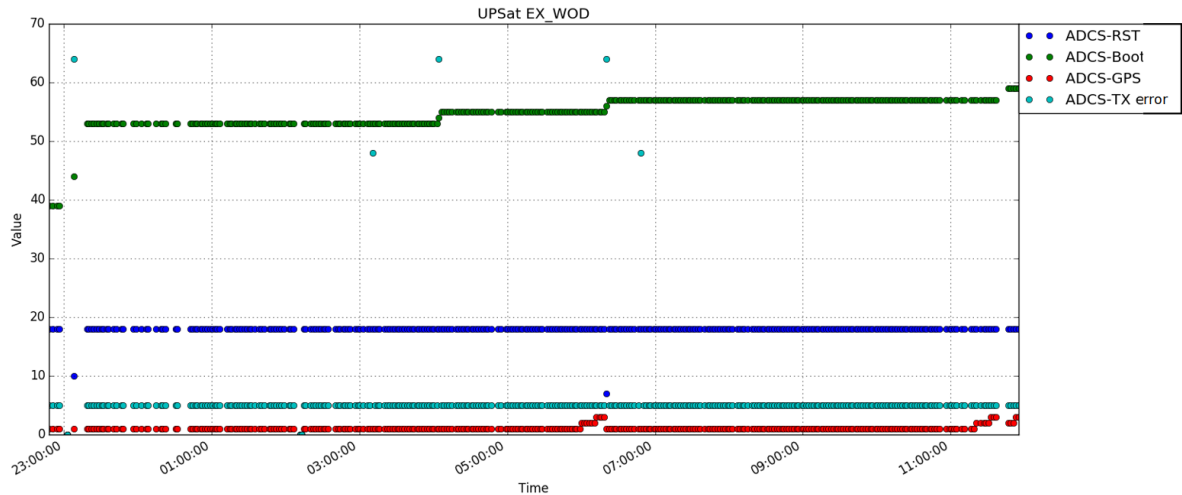
- TX ERROR 48, 64, means I2C bus is blocking
- TX ERROR 5, means no error in ADCS
- TX ERROR 37, means no sync time with OBC
- RST 7, means that ADCS is closed from EPS
- RST 18, means that ADCS is closed from WDT

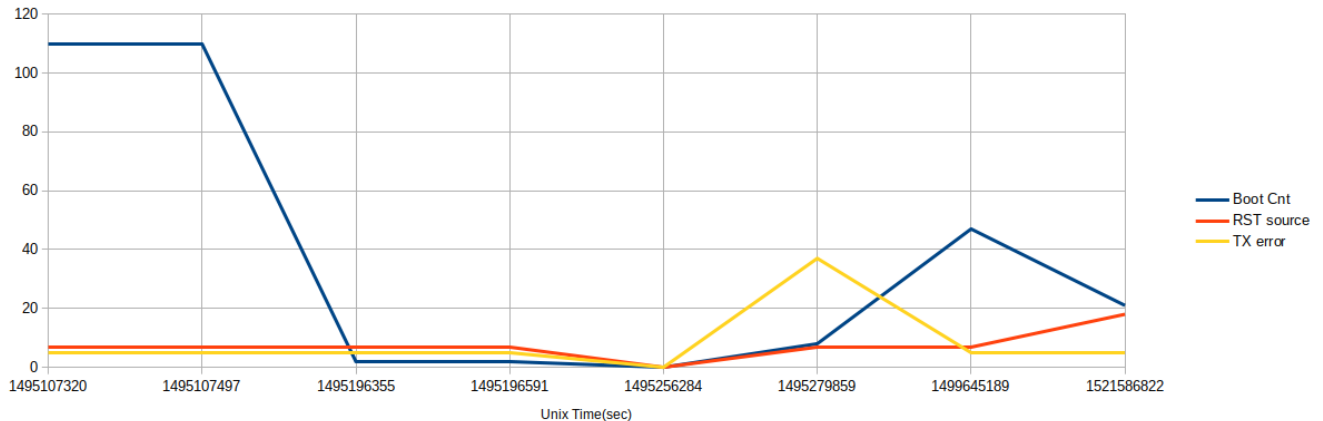
- Limited extended Whole Orbit Data (EXWOD) was received (8 packets from almost 200 WOD)
- Time Period: 18/05/2017 (near to launch day) to 20/03/2018 (dd/mm/yyyy)
- 1 EXWOD packet isn't valid (only zeros) at unix time 1495279859 sec

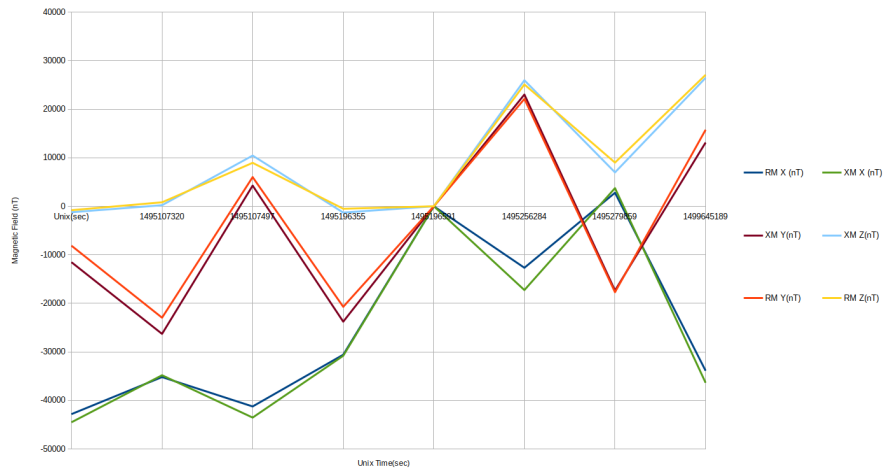
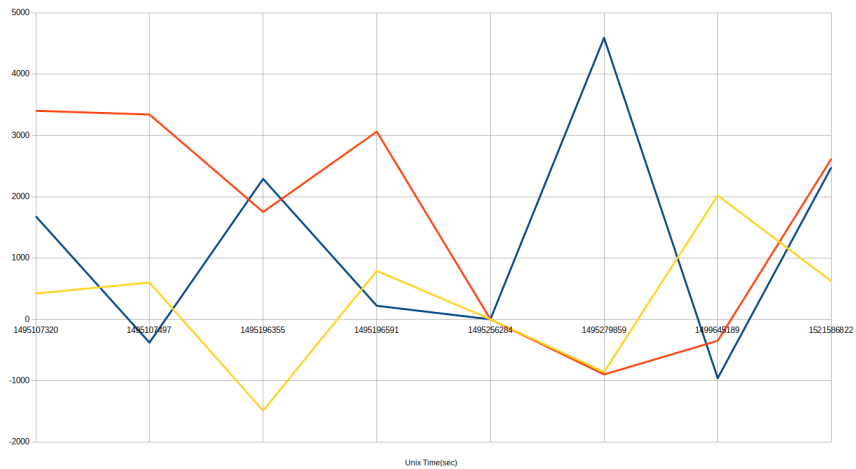
Never got Fix position

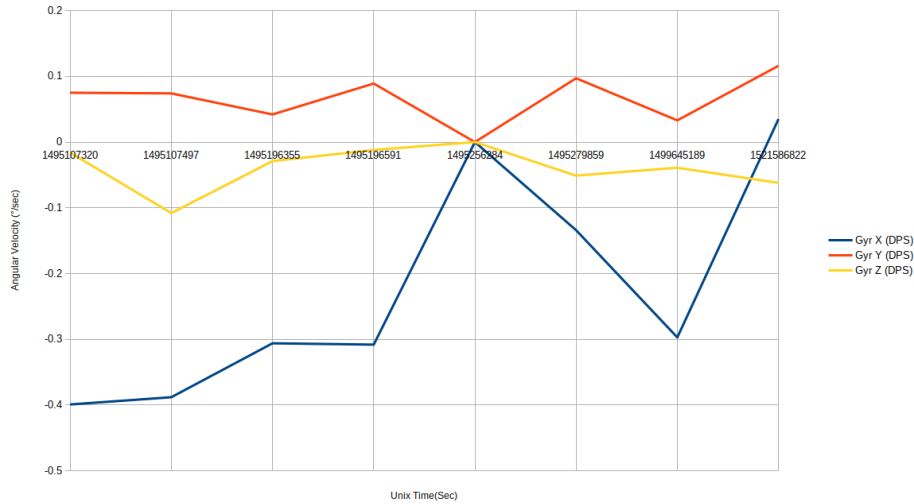
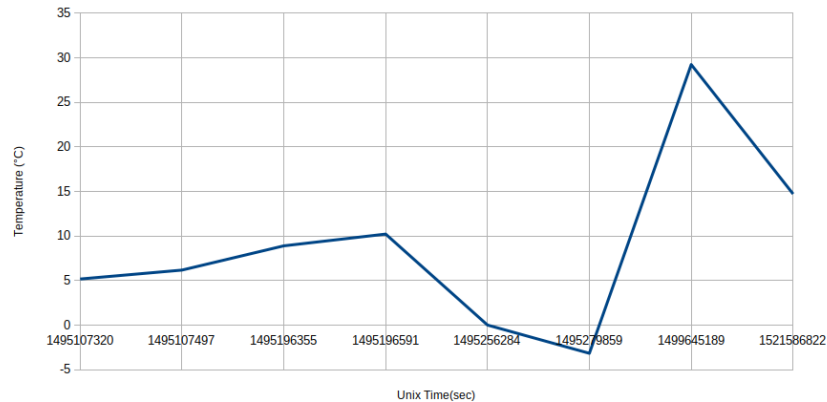
No valid Sun Sensor measurement, due to rotation in X-axis

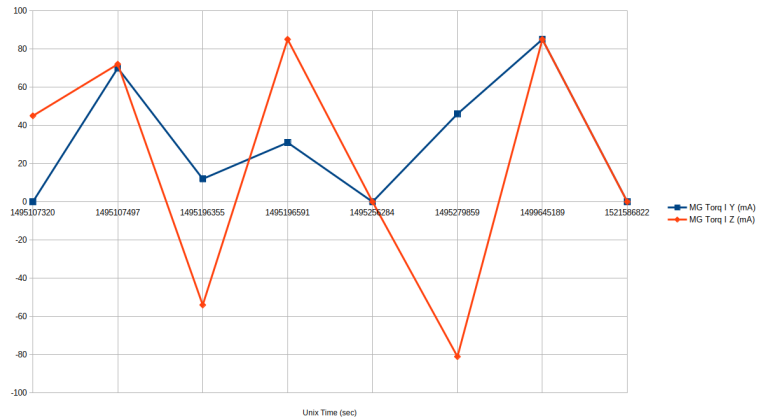
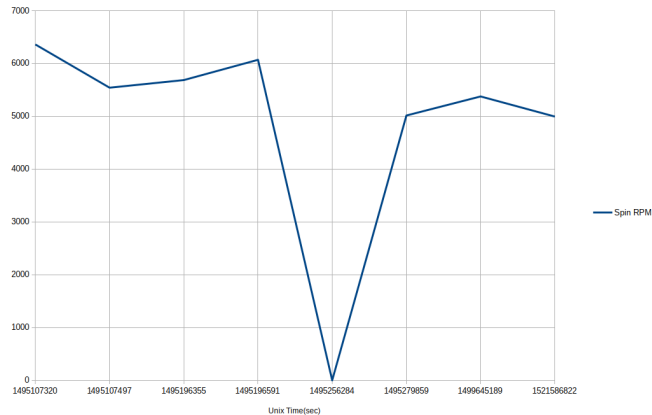
Spin Torquer constant offset: 5000 RPM
